MODEL--PROTOTYPE COMPARISON OF THE HYDRAULIC FORCES ACTING ON THE OUTLET COASTER GATE--SHASTA DAM--CENTRAL VALLEY PROJECT

Hydraulic Laboratory Report No. Hyd.-233

OCTOBER 25, 1948

Subject: Model--Prototype comparison of the hydraulic forces acting on the outlet coaster gate--Shasta Dam--Central Valley Project.

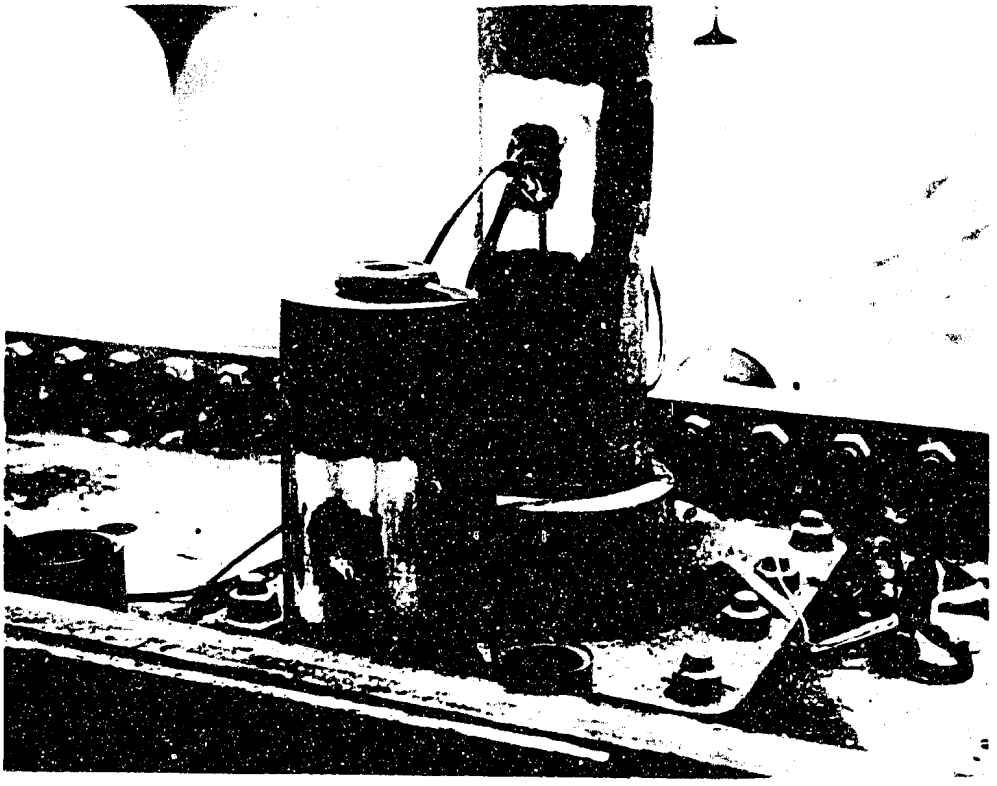
B – Strain gages for measuring forces on coaster gate.

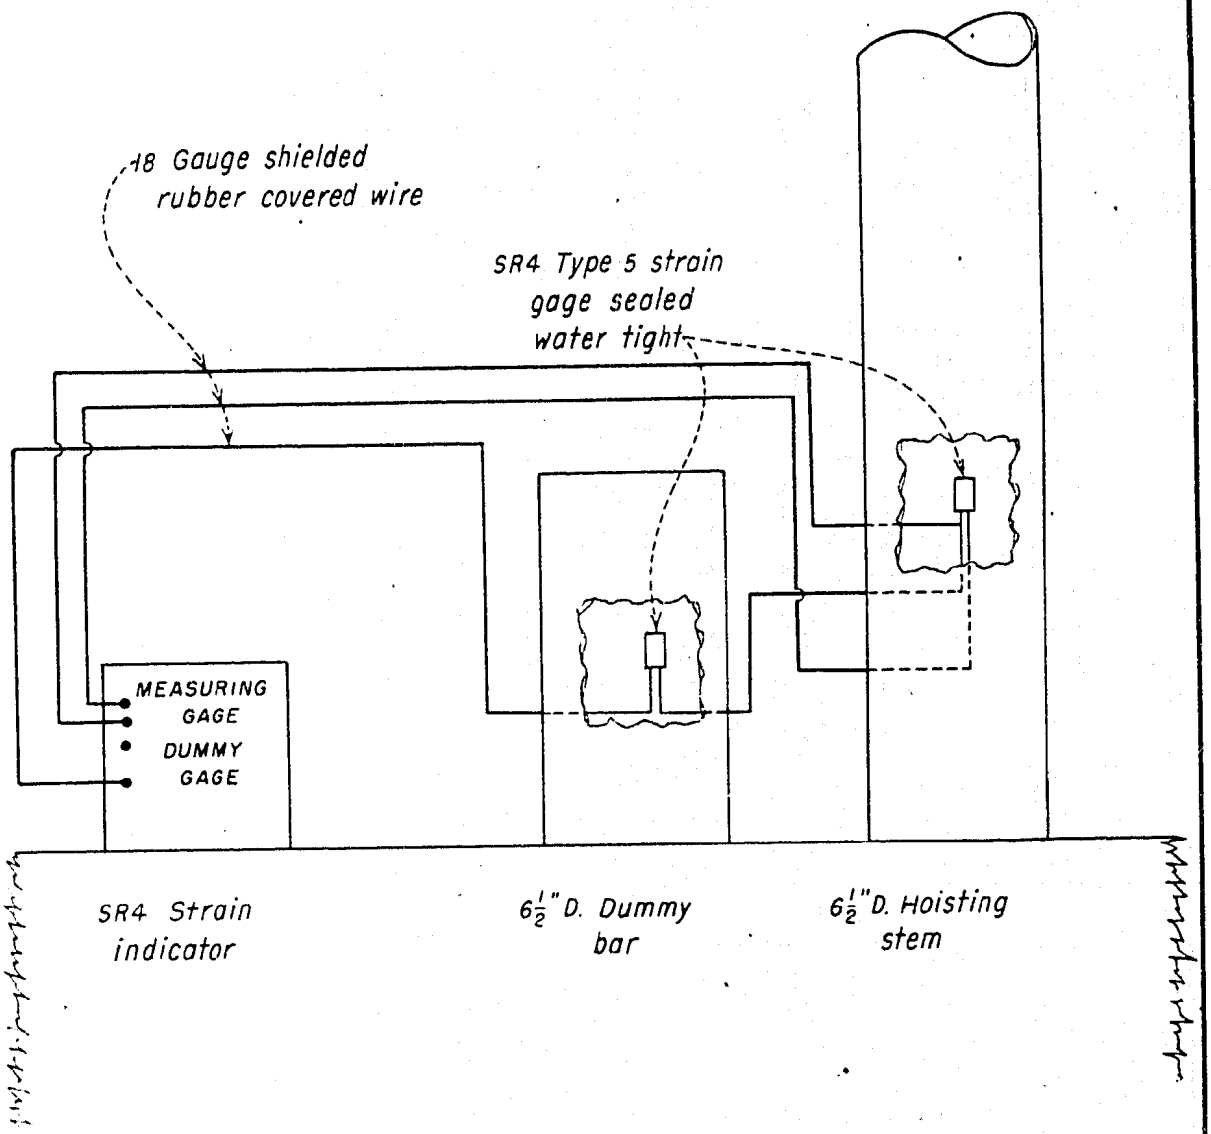
FIGURE 2

18 Gauge shielded rubber covered wire
SR4 Type 5 strain gage sealed water tight
MEASURING GAGE
DUMMY GAGE
SR4 Strain indicator
6½" D. Dummy bar
6½" D. Hoisting stem

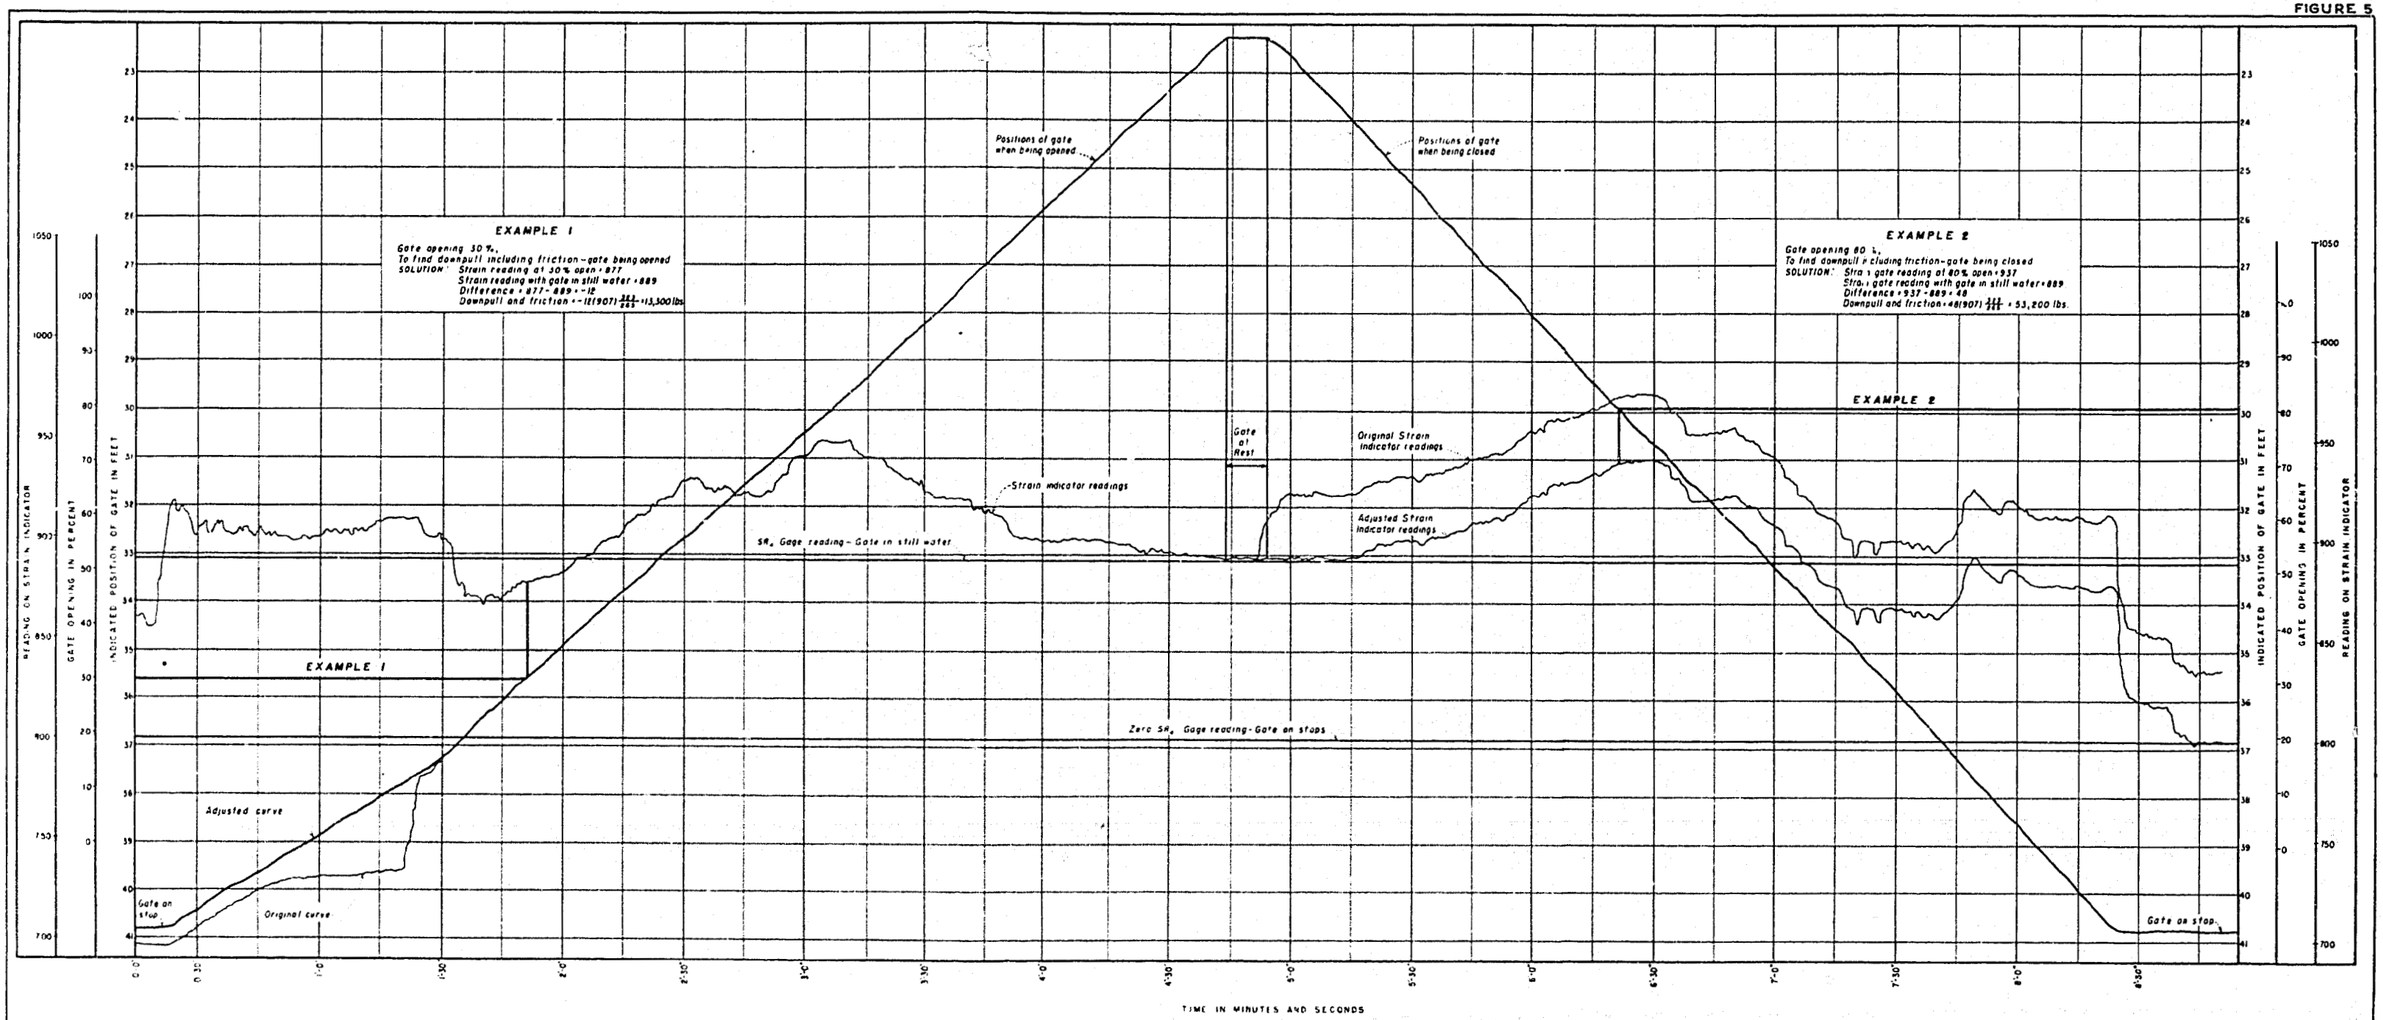
FIGURE 5

A discrepancy in the gate position indicator occurred during the initial part of the test due to failure of releasing the brake on the hoist used to lower the counterweight on the cable supporting the engineer's chain. The sudden jerk on the line when the brake was released caused a shift in the zero of the tape, which was corrected by observing the reading when the gate was lowered to the stops at the completion of the test.

A second inconsistency was apparent in that the strain increased approximately 30 points while the gate was suspended above the opening where balanced pressures existed. An additional increase of 6 points occurred during the closing cycle as evidenced by a comparison of the strain with the gate resting on the stops at the conclusion of the observations with that existing at the start of the test. Accordingly,

the portion of the curve expressing the relation of strain to gate position during the closing cycle was lowered approximately 36 points to obtain the true value. The relation between strain, gate position, and time after correcting the inconsistencies is apparent from Figure 5.

The increase of 36 points in the strain can only be attributed to the occurrence of a leak in the insulated wire permitting water to contact the electrical conductor, thereby increasing the resistance. This condition is further exemplified by the fact that the first entry of water would cause the greater increase in resistance corresponding to the 30 points while increasing the length of the electrical conductor in contact with moisture would cause a lesser change in the resistance resulting in the 6-point value.

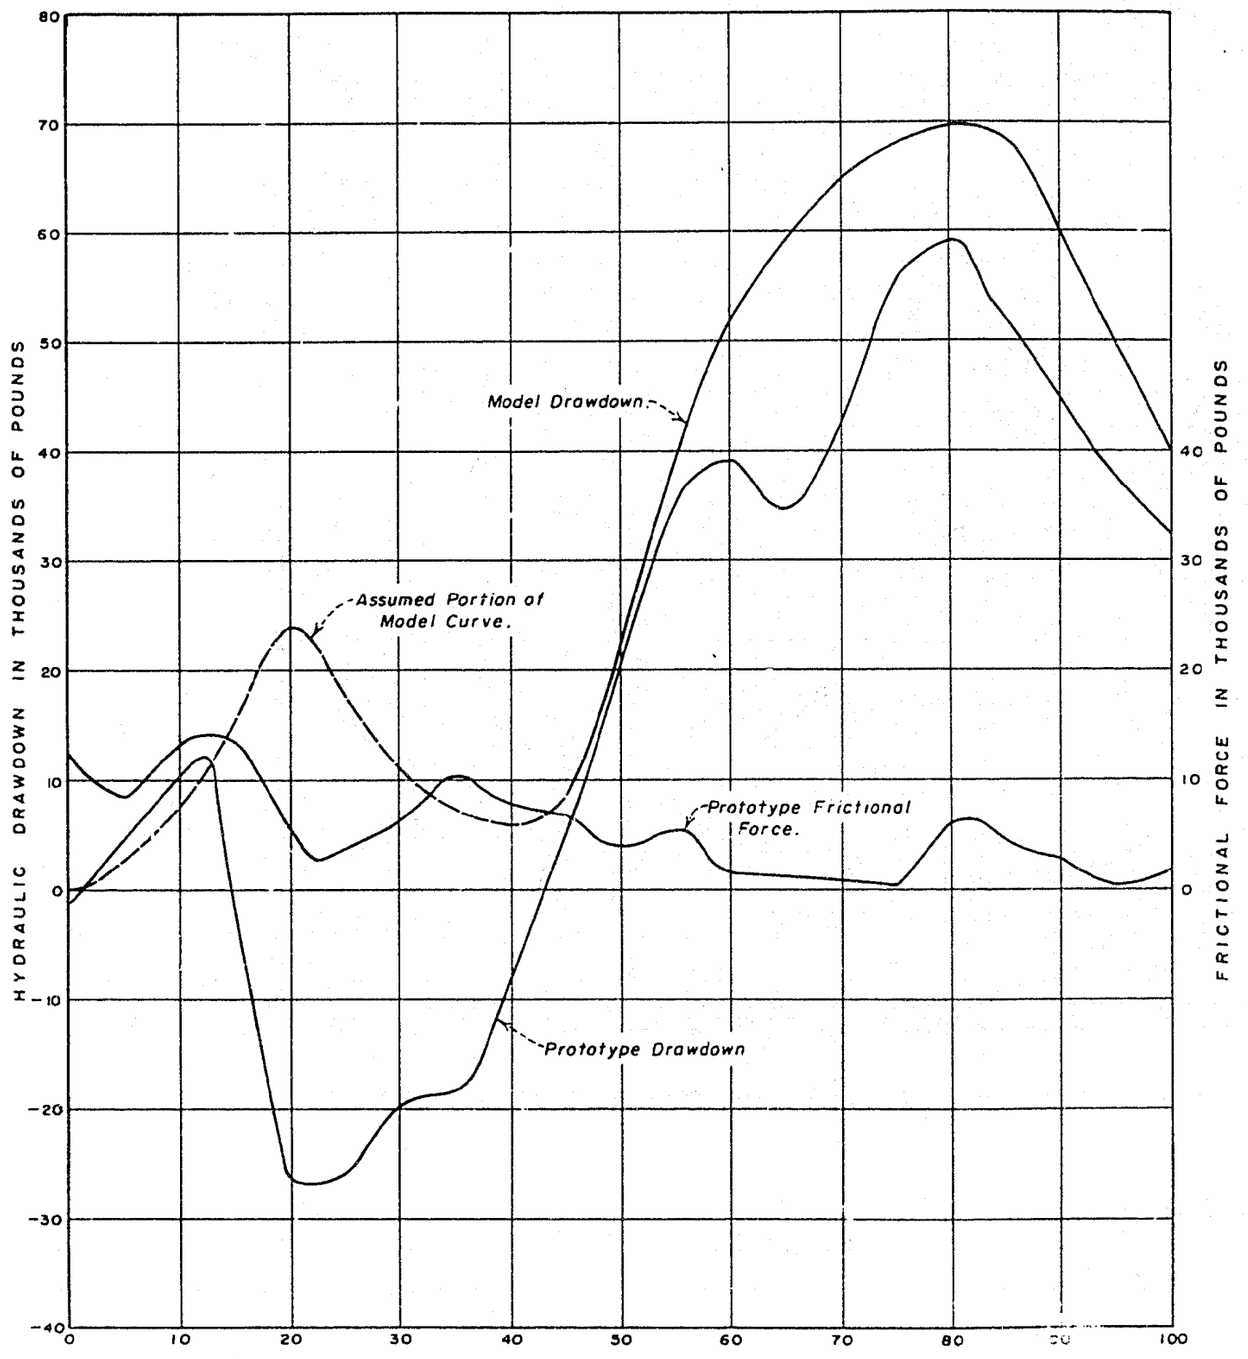
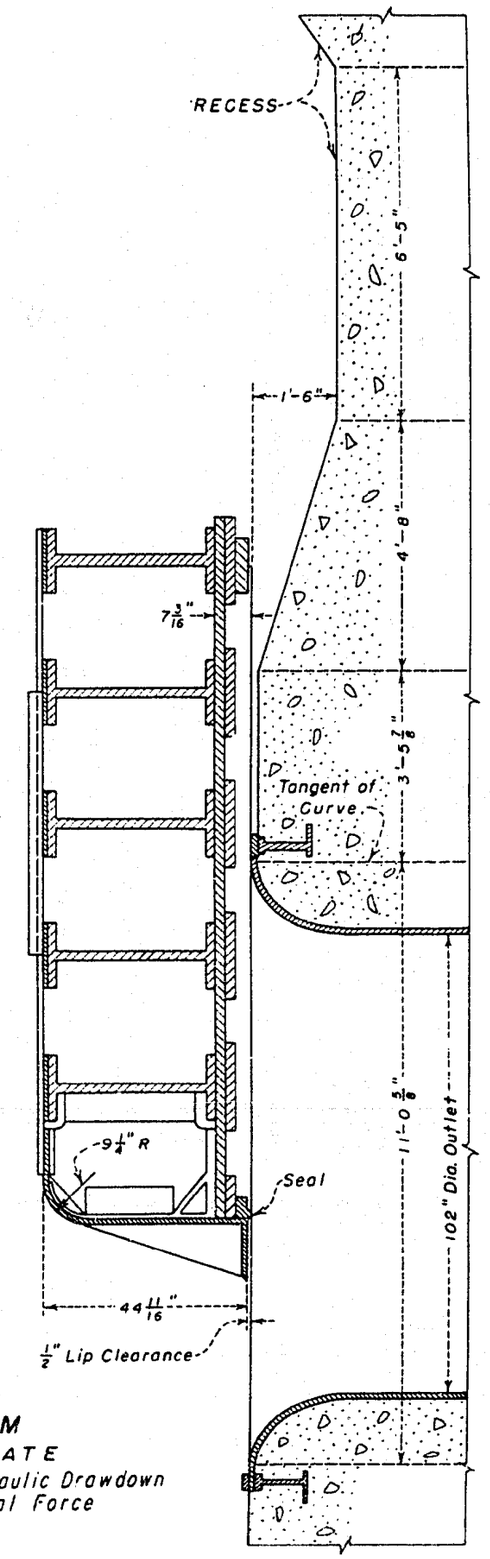
FIGURE 6

The relation between the friction force and gate opening is shown on Figure 6. All forces shown in this report are based on the maximum design head of 323 feet by increasing the values actually measured on the prototype structure by the ratio of $\frac{323}{265}$. In analyzing the results, it must be assumed that a linear relationship exists between the stress developed on the periphery of the hoisting stem and the total force acting on this member, and further, that a similar relationship exists between the deformation of the strain gage and its resistance.

The hydraulic downpull force was obtained by eliminating the forces due to friction and the weight of the gate. The relationship of this force to gate opening is shown on Figure 6. To permit comparison, the curve determined from observations on the hydraulic model is shown on the same plot. It may be seen that the maximum drawdown is 59,000 pounds of 11,000 pounds less than predicted. This variance of approximately 15.7 percent is not greater than should be expected for this type of measurement.

The characteristic of the curve determined on the prototype is different than the one obtained from the model at gate openings of 55 to 65 percent. The reason for the nonsimilarity is not apparent but is relatively unimportant in this region. However, the peculiar characteristic of the curve may have been caused by a mechanical condition resulting in a very small frictional force. In fact, the prototype data showed a negative friction force between gate openings of 67 to 73 percent which indicated that this force was less than the accuracy of the measurements.

Considerable variation exists between the model and prototype downpull curves for gate openings of 12 to 45 percent, due to the effect of the recess in the face of the dam immediately above the entrance to the outlet. As previously stated, this recess was one of the two design methods utilized to reduce the downpull force to a minimum; the other one being a lip on the bottom of the gate. The purpose of the depression was to balance the hydrostatic pressure on the upper horizontal projected seal assembly. Without such a recess the pressure on the lower side of the seal assembly would be low, the same as the pressure in the outlet entrance, hence the static pressure on top of the projection would exert a downward force increasing the total downpull. At the smaller gate openings, however, the model demonstrated that a negative downpull or uplift force existed which together with the friction force might prevent the lowering of the coaster gate. To avoid this condition, the recess was tapered so that as the gate closed the recess would begin to lose its effectiveness at an opening of 45 percent and become entirely ineffective at an opening of 20 percent. It is apparent that the recess would also lose its effect at gate openings larger than approximately 80 percent since the lower horizontal projected seal assembly would then occupy a position causing unbalanced pressure.

Referring to Figure 6, uplift forces did exist indicating that the recess did not begin to lose its effectiveness until the gate was lowered to an opening of approximately 20 percent. This exemplifies the possibility of encountering a condition preventing the closure of a gate without applying mechanical forces in addition to the dead weight.

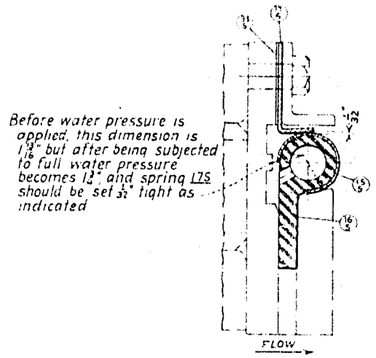
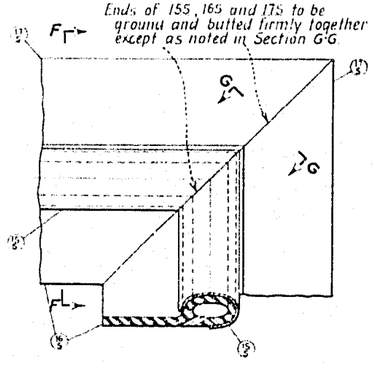
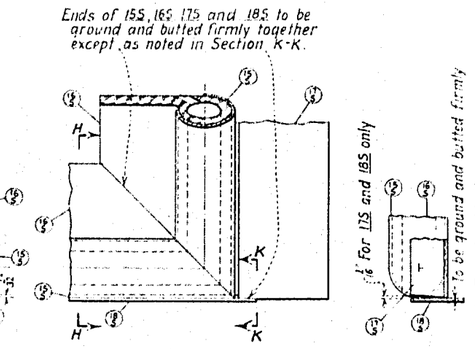
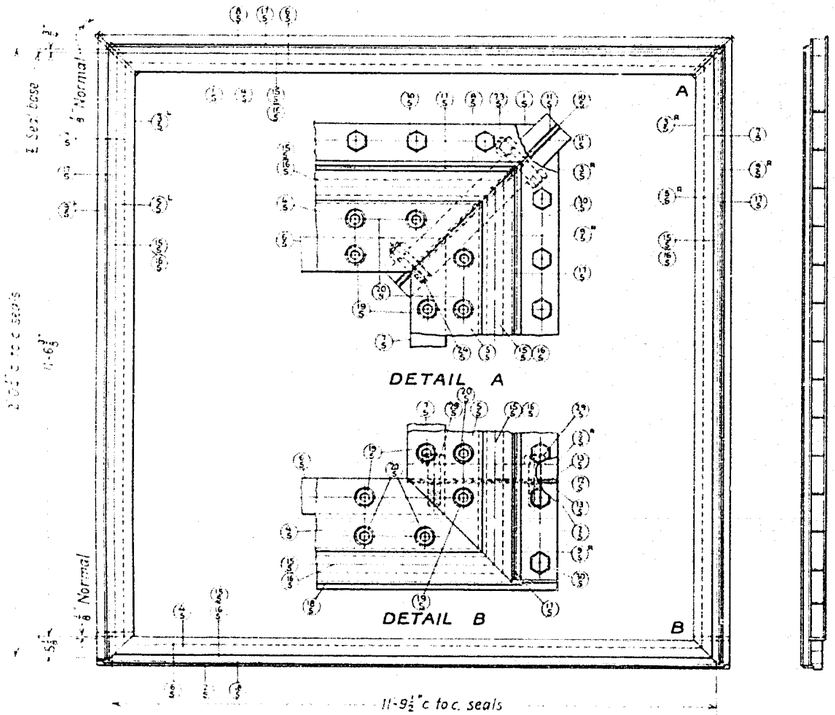
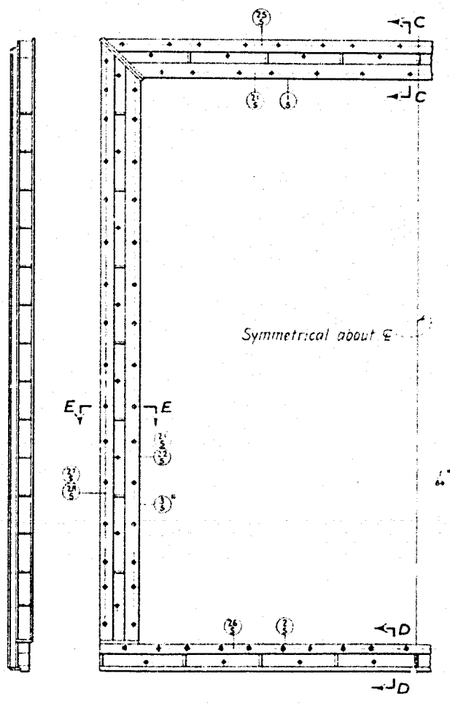
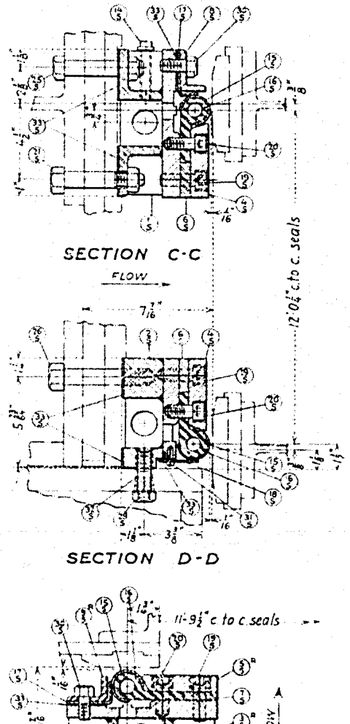
Previous to the conduct of the test of the coaster gate the "music note" seals had been damaged and removed from the gate. Since the guards, Parts 8S, $9S^R$, and $9S^L$, Figure 8, were in place, the space between the gate and the seal seat on the face of the dam was only slightly greater than with the seals in place. This factor could not conceivably affect the magnitude of the maximum downpull force but could possibly result in a lower gate position at the point where the recess became ineffective. However, any effect due to the absence of the seals is considered to be negligible.

It is significant that the bottom sheath was rolled upward revealing that the damage had occurred while the gate was being lowered. The flattened portion of the side sheaths indicate that the upper portion of the side seals which were above the seat on the face of the dam were extended while lowering the gate with unbalanced pressure and that the force against the seat as the gate lowered was great enough to smash the sheaths. Hence, it can only be concluded that the seals were protruded when the gate was operated with unbalanced pressure.

The failure of the seals to retract because of faulty operation of the seal actuator assembly cannot be considered, as inspection by project personnel revealed that the apparatus was in proper working condition; therefore, it must be assumed that the "music note" seals were extended because of hydraulic forces. It was noted that the portion of Parts 17S and 18S which contact the flexible seal, Figure 8, was crooked, and hence, a continuous contact could not conceivably be obtained. This factor alone would prevent retraction of the seals by admitting reservoir pressure to the channel behind the seals.

There are two obvious reasons which may have contributed to the failure of the springs (Parts 17S and 18S) to seal the chamber immediately behind the seals: (1) Steel was used instead of brass because of the critical material situation imposed by the recent war; and (2) the tolerances maintained during the assembly of the mechanism may not have been as rigid as desired. The importance of the latter factor cannot be overemphasized and was demonstrated in the hydraulic model study[2] made in connection with the design of the gate seals.

It should be pointed out that the seals under consideration are obsolete, since in later designs the metal sheath has been replaced by a brass section welded to the rubber to prevent extrusion. Although this new type seal may minimize the possibility of extrusion of the rubber, it is not conceivable that its performance will be materially different than the one described for Shasta Dam unless the channel behind the seals is closed to enable the development of a low pressure to retract the seals.
